REFURBISHMENT

Sika[®] FerroGard[®]-903 Plus

THE UNIQUE MULTI-FUNCTIONAL SURFACE APPLIED CORROSION INHIBITOR FOR REINFORCED CONCRETE

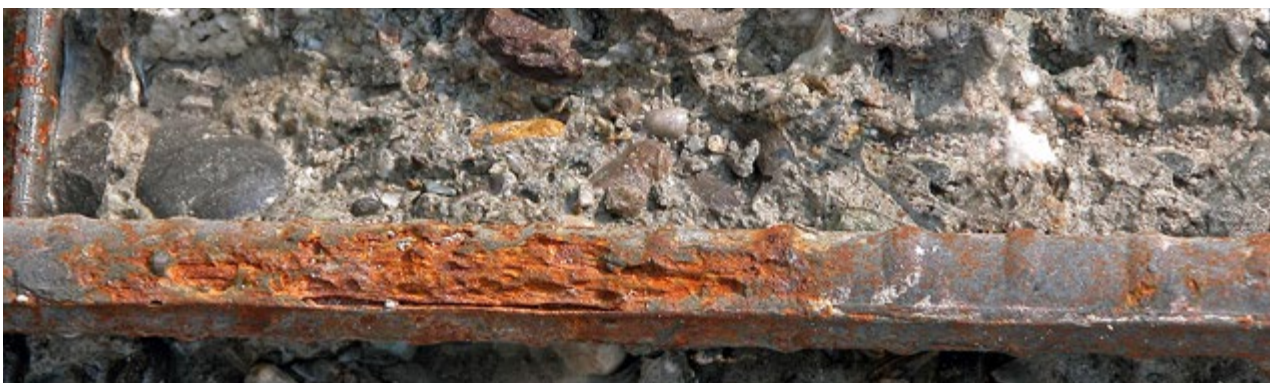
Chlorides/Carbonation

As soon as sufficient chloride ions (from deicing salts or marine exposure) or the carbonation front have reached the steel surface, the passive layer is destroyed and corrosion accelerates.

Contact with water (moisture)

The original neutral iron will receive a negative charge as the positively loaded ions have the tendency to dissolve. The water film around the metal turns positive.

Contact with oxygen

The oxygen takes on the negative charge of the iron ions which have gone into solution. The result is iron hydroxide, the first stage of rust.

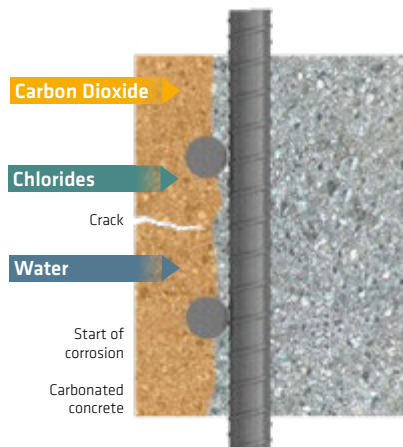
WELL ADVANCED CORROSION RISK BUT NO VISIBLE CORROSION DAMAGE

Concrete façade or civil engineering structure without protective coating.

- Steel reinforcement in a carbonated environment
- Perhaps light corrosion already exists
- No visible corrosion damage

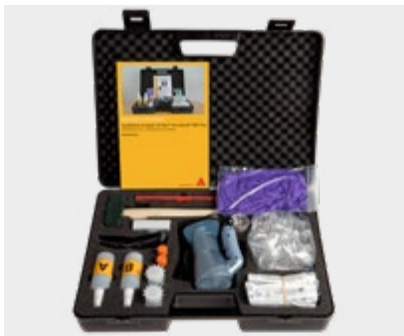
The Sika qualitative Color Test Kit for penetration depth testing.

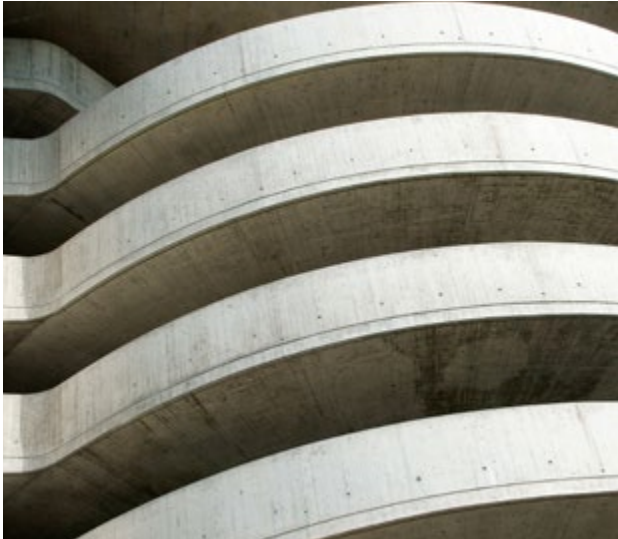
REPAIR AND PROTECTION – MULTI STOREY CAR PARK

- Reinforced concrete decks with cracked and spalling concrete
- Corrosion of reinforcement in carbonated and chloride contaminated concrete

- Reduce high and low corrosion rates by anodic, cathodic control and concrete resistivity principles
- Repair cracked and delaminated concrete and protect from future chlorides and carbonation
- Controlled concrete breakout
- Minimum 10 years to next maintenance
- Cost-effective solution

- Clean concrete surfaces
- Application of Sika® FerroGard®-903 Plus
- Concrete repairs and reprofiling with e.g. Sika MonoTop®-412 N
- Application of Protective Sika® Deck Coating System
- Application of e.g. Sikagard®-675 W carbonation protective-coating to soffits

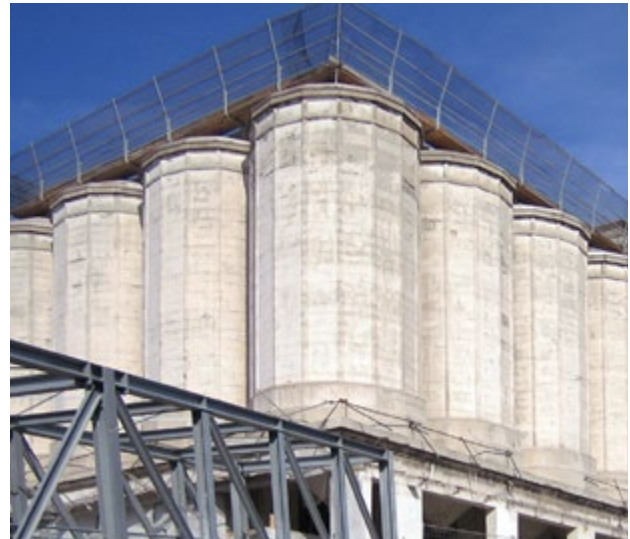
REPAIR AND PROTECTION – CONCRETE SILOS

- Cracked and spalled concrete cladding panels with low concrete cover to reinforcement
- Defective waterproof joints between panels
- Corrosion of reinforcement in carbonated and chloride contaminated concrete

- Limit noise and dust
- Controlled concrete breakout
- Short repair program
- Control corrosion of steel by anodic, cathodic and concrete resistivity principles
- Up to 15 years maintenance free period
- Re-sealing of cladding joints

- Depth of penetration and permeability assessment trials to prove suitability of Sika® FerroGard®-903 Plus
- Clean concrete surfaces
- Application of Sika® FerroGard®-903 Plus
- Concrete repairs and reprofiling with e.g. Sika MonoTop®-352 N light weight mortar
- Application of e.g. Sikagard®-690 W HD long-term performance protective coating
- Application of e.g. Sikaflex® AT-Connection for construction joints
