CAR PARKS REFURBISHMENT

BUILDING TRUST

MEETING YOUR NEEDS ON EVERY LEVEL

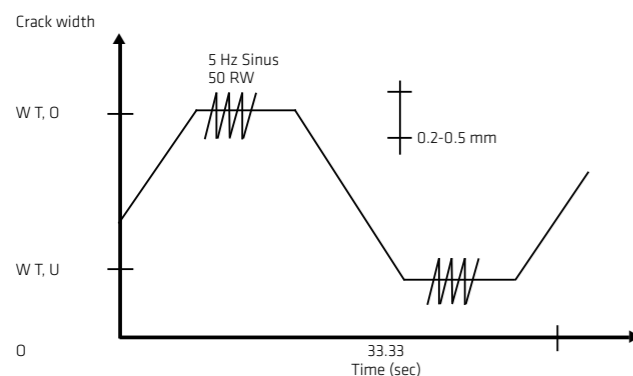
Example of test method used to determine crack bridging properties: (EN 1062)

System: OS-11
 Classification: II T+V, dynamic
 W T, O = 0.50mm upper crack width
 W T, U = 0.20mm lower crack width
 $\Delta W V = 0.30mm$ change of crack with through traffic

Note: the graph is showing 1 cycle, the tests involves a total of 20,000 cycles @ -20°C

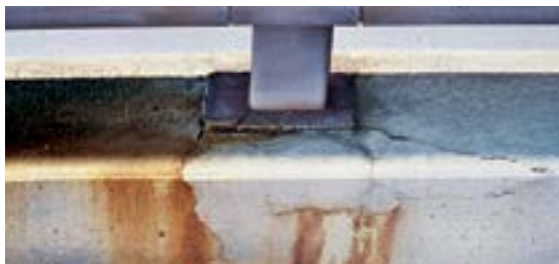
MOVEMENT

- Ground movement or movement of the structure or of individual components, eg at construction joints, expansion joints is usually visible. Parking structures in use are always subject to dynamic loading

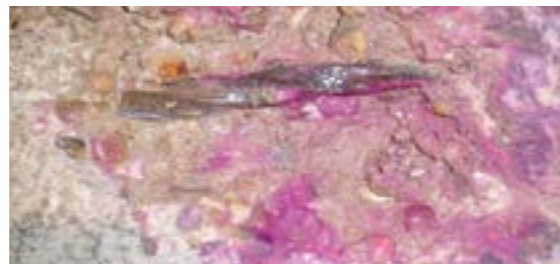
ATMOSPHERIC CARBONATION

- Atmospheric carbon dioxide gradually and progressively reduces the protective alkaline layer around the reinforcement, which will allow the steel to corrode

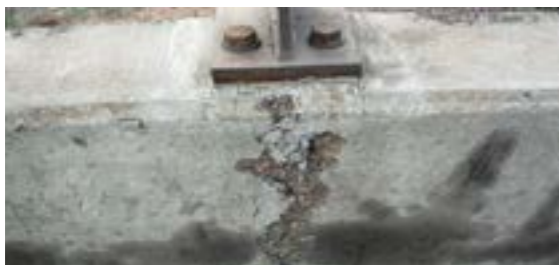
THERMAL VARIATIONS

- Sunlight causes thermal expansion and stress cracking
- Frost causes thermal contraction and freeze / thaw damage
- Ultraviolet light causes degradation of organic materials, ie waterproofing membranes, resin and coatings

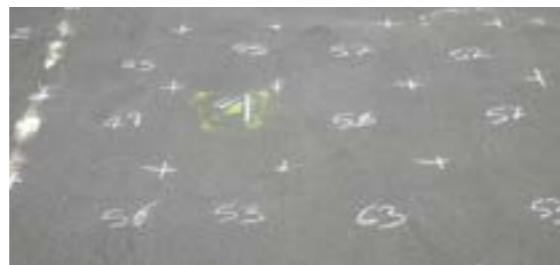
DE-ICING SALTS

- De-icing salts are based on chlorides. The penetration of water contaminated by de-icing salt into concrete cause corrosion of embedded steel reinforcement and often cracking, spalling and delamination of concrete cover

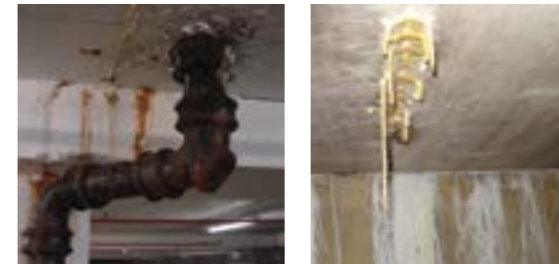
RAINWATER

- With water filling the pores and capillaries, concrete becomes susceptible to freeze/thaw damage
- In carbonated concrete water ingress will allow steel reinforcement to corrode

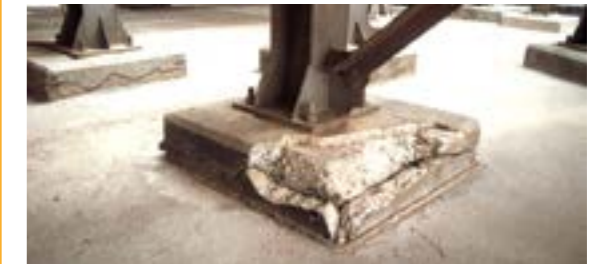
MECHANICAL EXPOSURE

- The decks of parking structures are exposed to different levels of mechanical stress, according to their location and function, ie:
 - Pedestrian levels: walkways
 - Standard levels: in primary parking bays
 - Heavy levels: entrance and exit areas, ramps and turning cycles

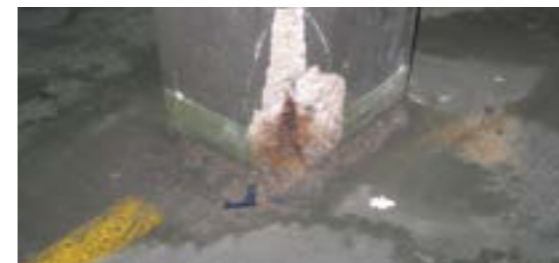
AGGRESSIVE POLLUTANTS

- Acidic oxide gases of sulphur and nitrogen from exhausts diffuse into the condensation and attack and corrode the concrete surface, which reduces the strength and increases the porosity
- Some liquids, such as hydraulic brake fluid, are very aggressive and will attack concrete and steel surfaces

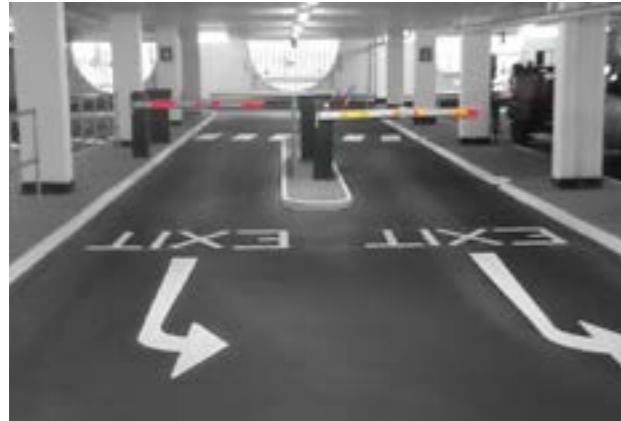
SIKA HELPS BRIGHTEN BASILDON CAR PARK

The multi-storey car park at Basildon's Eastgate shopping centre has parking spaces for 650 cars. Before refurbishment, the car park was dark and quite dingy and not offering a particularly welcoming environment to visitors to the centre. The parking bays were tight, designed for cars from the 1980's and quite unsuitable for many modern vehicles.

The car park was in need of major refurbishment. Continual exposure to chlorides from de-icing salts, carbon dioxide and water penetration, had caused the concrete to spall as the steel reinforcement within had corroded. A repair solution that would inhibit future corrosion taking place was required together with a durable coating and decking system that would ensure the future integrity of the structure.

Sika were able to provide a single source supply for concrete repairs, corrosion management and both deck and soffit coatings. Spalled areas of concrete were removed and soffit repairs carried out using the Sika® MonoTop® system. This one-component system has the advantage of easy handling and application, with high build qualities. Decks were repaired using Sika® Rapid Repair mortar, a cementitious mortar with high early strength, which kept the time out of service to a minimum.

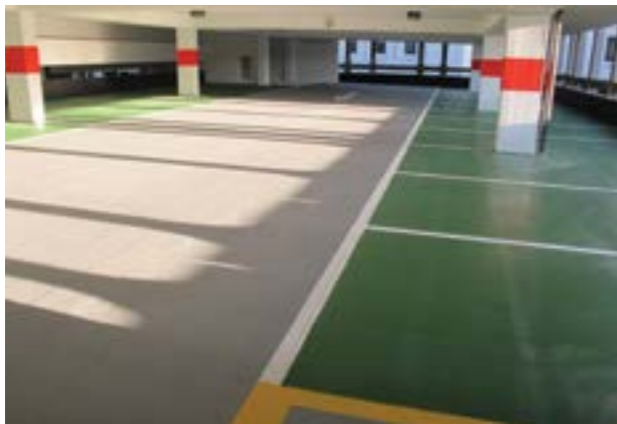
HIGH CHELMER CAR PARK AGEING CAR PARK GET NEW LEASE OF LIFE

A comprehensive range of concrete repair, corrosion management and waterproof car park decking products from Sika has helped transform Chelmsford's 1960's High Chelmer multi-storey car park into a safer, more stylish and modern parking facility. Completed to such a high standard, the project was shortlisted in the Best Car Park Refurbishment category at the British Parking Awards 2012.

In March 2011, following the discovery of localised instances of concrete spalling due to expansive corrosion of the reinforcement bars, Chelmsford Borough Council acted upon professional advice from the structural and civil engineers to close High Chelmer Car Park and Retail Market to allow significant repairs and a full refurbishment to be completed.

During site inspections it was discovered that the car park required 1,500m² of repairs – 50% more than the original figure of 1,000m². It was anticipated that the concrete required repairs to a depth of 75mm, however, on commencement of work this was amended to 85mm.

Sika, offered a full range solution for the concrete repair corrosion management using a combination of Sika® Galvashield® XP2 sacrificial anodes, Sika® Ferrogard®-903 migrating corrosion inhibitor and 120 tonnes of Sika® Armocrete flowable micro-concrete.

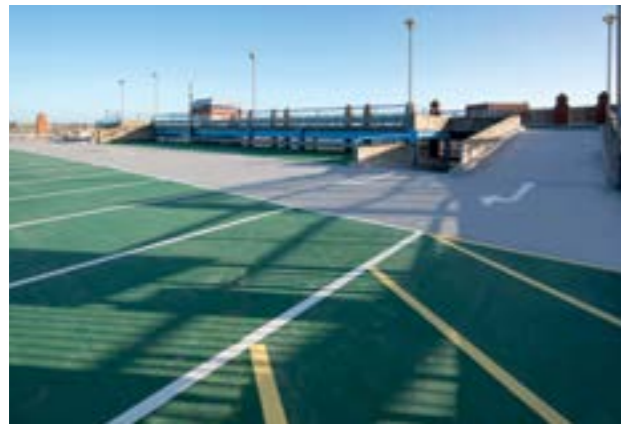
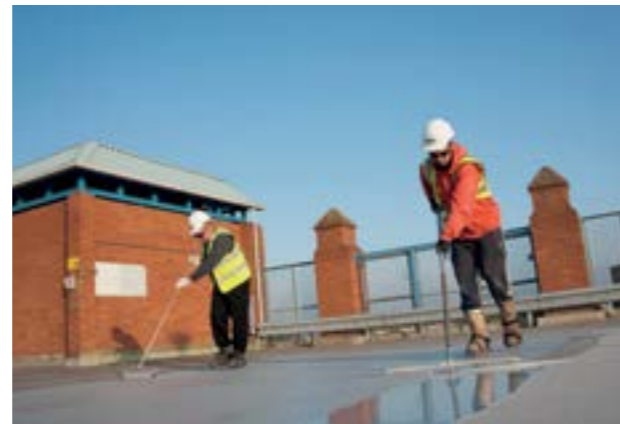
SIKA HELPS RAPIDLY REPAIR UPPER HUNDREDS CAR PARK

Upper Hundreds MSCP is located in Aylesbury Town Centre with spaces for 305 vehicles. The car park, which is owned by Aylesbury District Council, was suffering from a failed waterproofing system on its top deck, allowing water ingress into the lower decks of the car park. This water ingress had caused spalling to the concrete screed, to the ramps and pedestrian walkways.

After further testing it was found that the concrete substrate did not have sufficient cohesive strength to support the application of a new car park deck system without further case hardening.

To remove existing failed coatings and concrete screed and repair damaged concrete on deck, ramps and soffits. Apply a case hardening resin to increase the cohesive strength of the concrete and apply a waterproof car park deck system, with fast setting properties, to prevent further water penetration and resulting damage.

Concrete repairs were carried out using Sika® Rapid Repair Mortar, a cementitious mortar with high early strength. The high early strength property ensured that the time the deck was out of service was kept to a minimum.
